NPDES
INSPECTION REPORT

DRINKING WATER TREATMENT FACILITY
PIERCE, IDAHO

October 20, 2011

Prepared by:
Jerry W. Shaffer
Lewiston Regional Office
Idaho Department of Environmental Quality

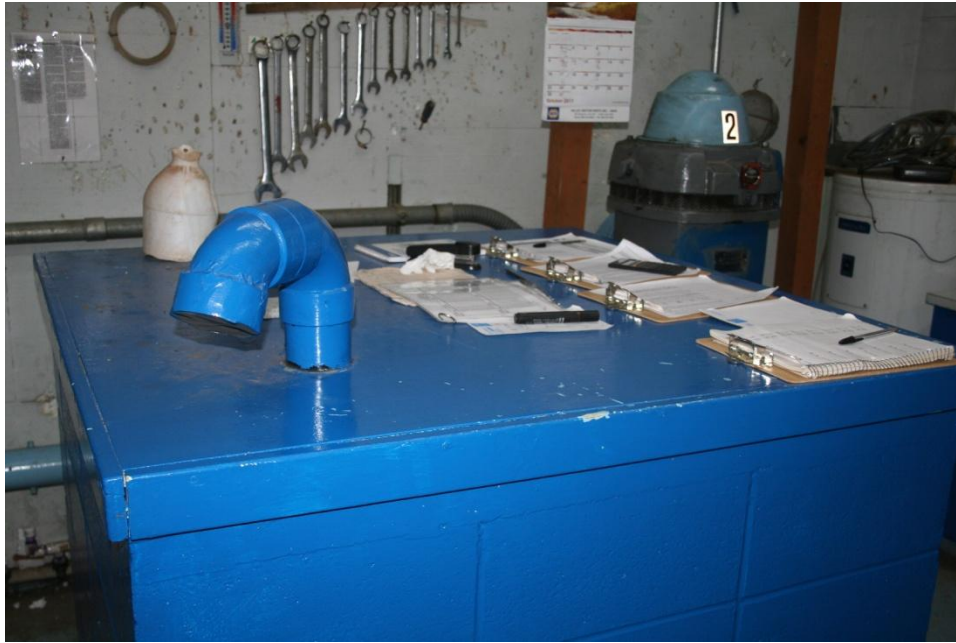
Pierce Drinking Water Treatment Plant laboratory facilities (photo 1). Photo by Jerry W. Shaffer (DEQ) on October 20, 2011.

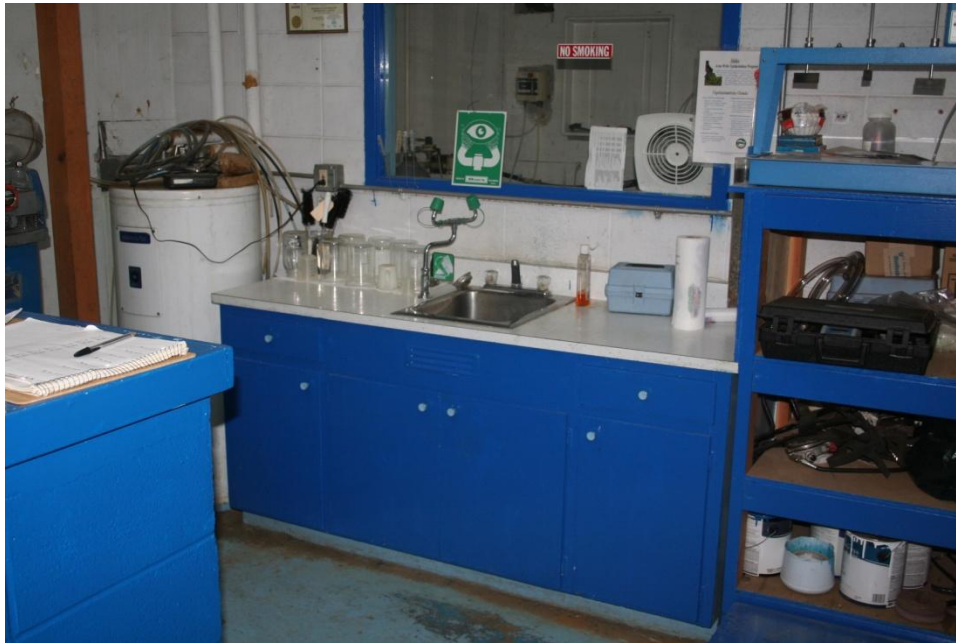
Pierce Drinking Water Treatment Plant laboratory facilities (photo 2). Photo by Jerry W. Shaffer (DEQ) on October 20, 2011.

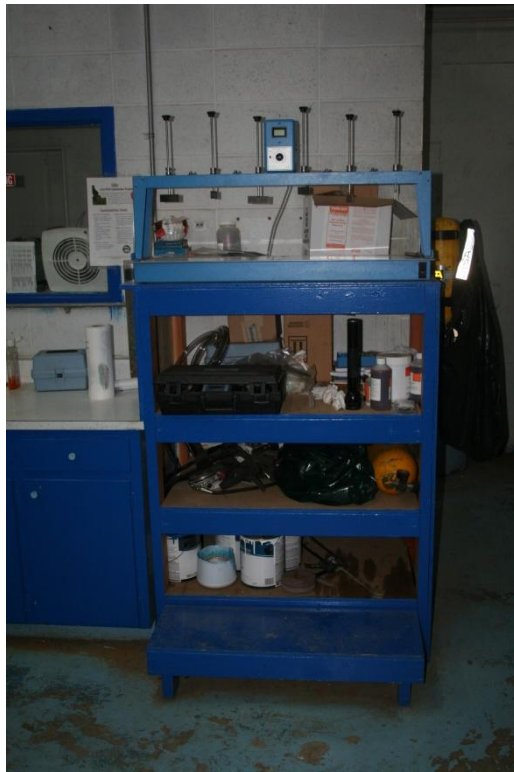
Pierce Drinking Water Treatment Plant laboratory facilities (photo 3). Photo by Jerry W. Shaffer (DEQ) on October 20, 2011.

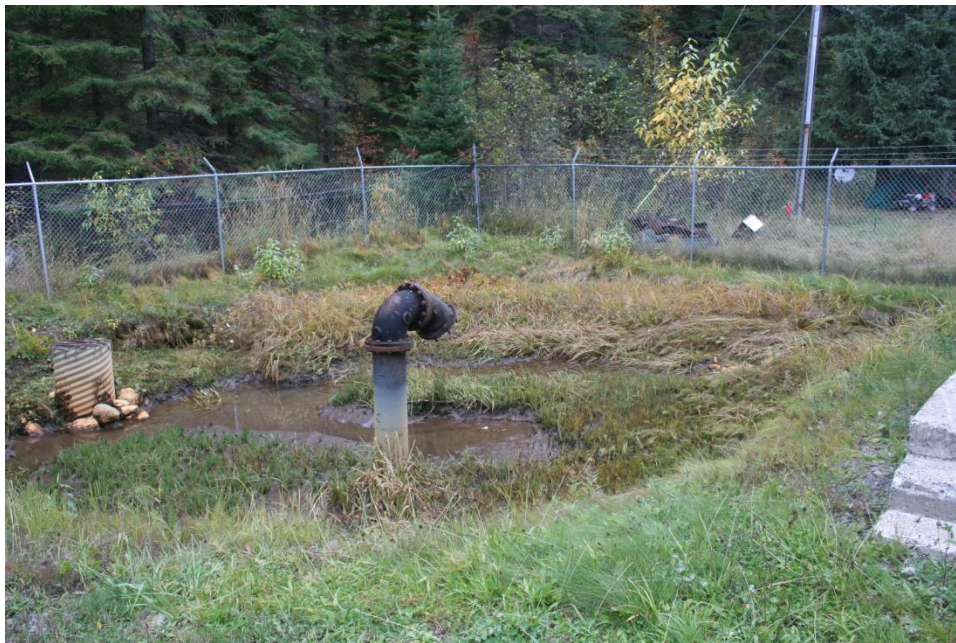
Pierce Drinking Water Treatment Plant backwash settling pond (photo 1). Photo by Jerry W. Shaffer (DEQ) on October 20, 2011.

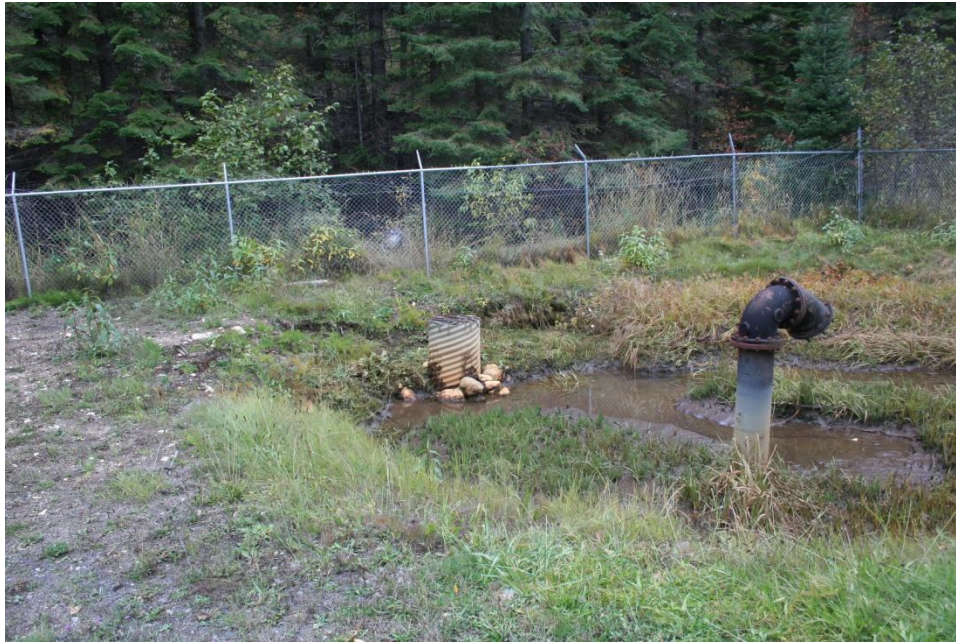
Pierce Drinking Water Treatment Plant backwash settling pond (photo 2). Photo by Jerry W. Shaffer (DEQ) on October 20, 2011.
